## Model ANT-151D-GIS

Ground Independent, Half Wave  
VHF Mobile Antenna  
151.3 MHz  
2.1 dBi gain

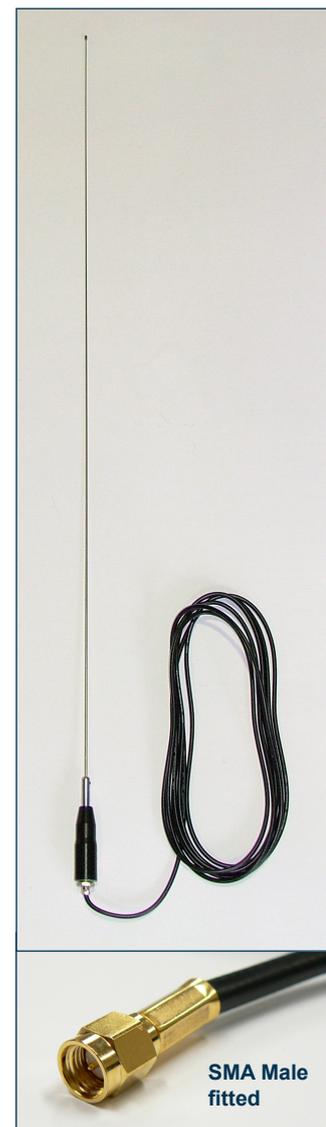
The **GRH/TL** mobile antenna is a ground independent, half wave, end fed design ideally suited for use where no metal ground plane exists. In practice these antennas are also used where some metal is present but where it is not of sufficient area to allow a normal quarter wave whip to be mounted.

Factory tuned for 151.3 MHz with 2.1 dBi gain, the antenna stands 1.17 metres tall. The stainless steel, delrin, copper and brass construction provides an extremely robust and durable antenna capable of surviving the harshest of conditions and treatment.

4 metres of RG58 stranded cable bottom exits through the antenna base. The cable is fitted with an SMA Male connector. Mounting is to any bracket with a 10 mm hole using the stainless steel nut and washer on the base ferrule. Typical mounting positions are to a vehicle guard, vehicle boot or truck mirror using the appropriate bracket.
